# COMMON PROBLEMS IN PCB DESIGN

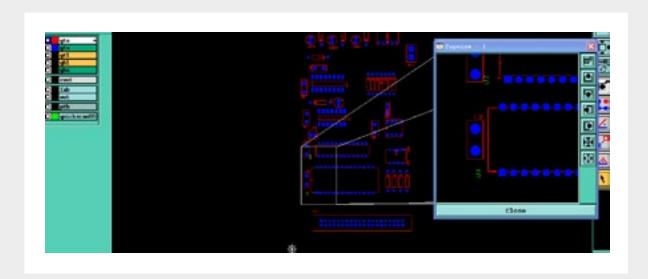
### CONFIRM SILKSCREEN CHARACTERS.

In this example, the customer requested to have top silkscreen on the boards. An extra layer was added that, when viewed, looked like it should be added to the silkscreen layer. Without any instructions the manufacturer had no choice but to hold production and clarify.
